PUBLIC WORKS CENTER PEARL HARBOR FLEET MOORINGS UNDERWATER INSPECTION REPORT

SEPTEMBER 1983

OCEAN ENGINEERING
AND CONSTRUCTION PROJECT OFFICE
CHESAPEAKE DIVISION
NAVAL FACILITIES ENGINEERING COMMAND
WASHINGTON, D.C. 20374

FPO-1-83(22)

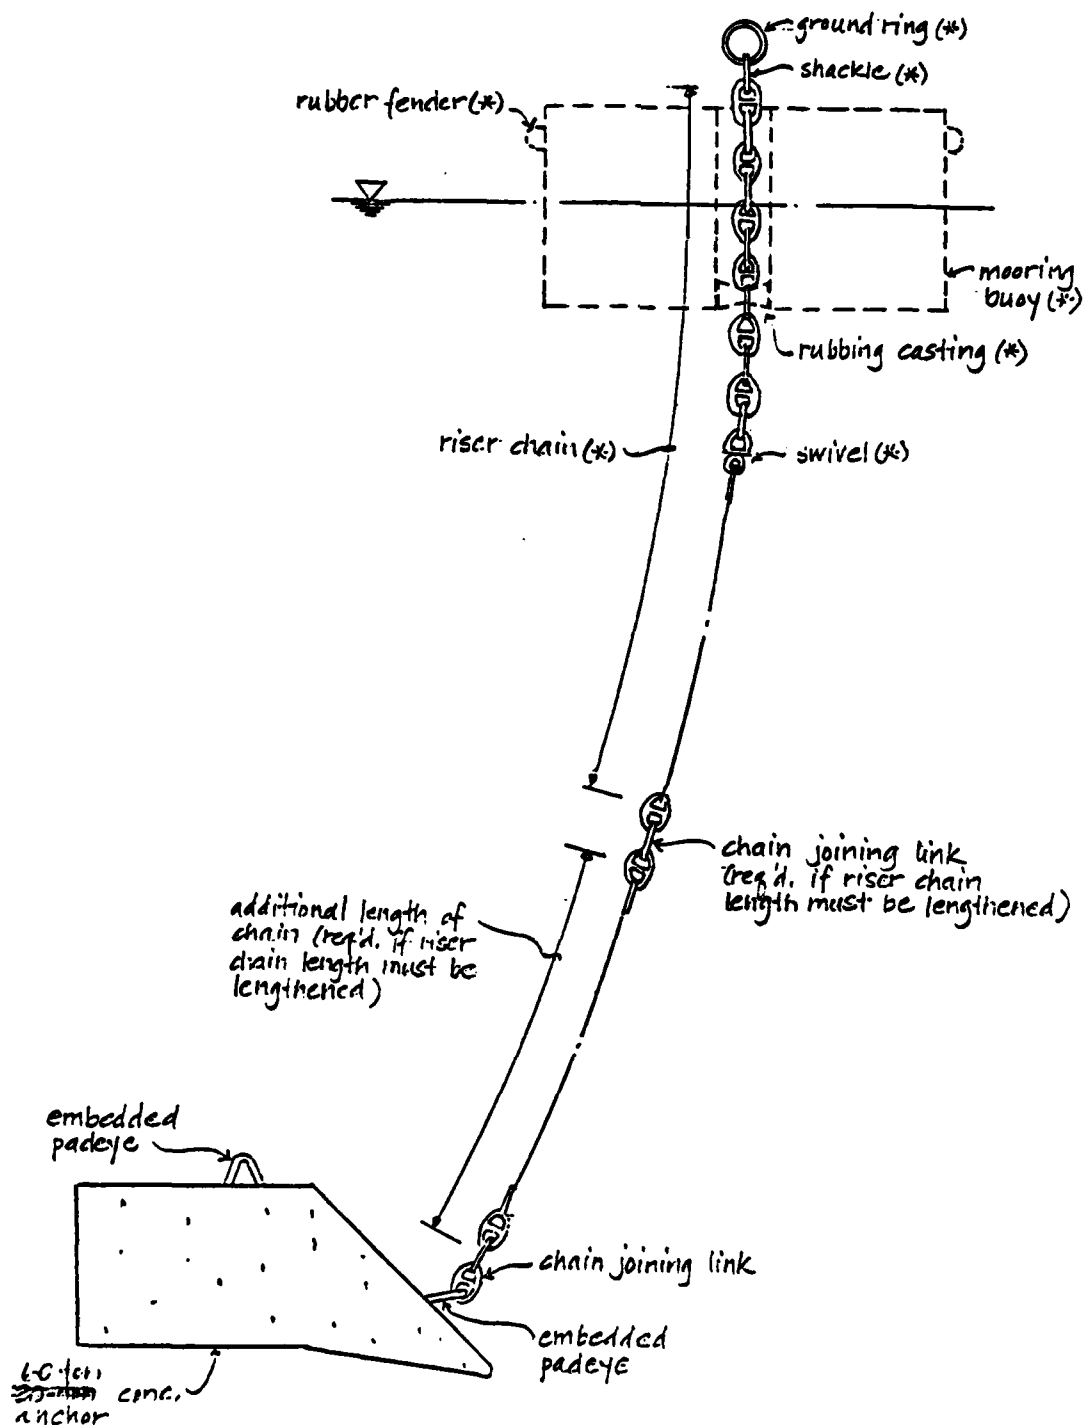
**MOORING DP2N
SCHEMATIC DRAWING**

INSPECTION RESULTS

This is a 12-foot-diameter, 6-foot-high drum-type buoy with a hawsepole. The buoy is fiberglass coated and has two rubber fenders and a galvanized pipe chafing rail. The mooring was overhauled in March 1982, and the buoy is in good condition. The top jewelry wire diameter measurements were all greater than 90 percent of their original diameter size. The bottom is covered with 2 inches of marine growth.

The riser chain and accessories were replaced during the 1982 overhaul with oversized 4-inch chain in order to moor LHA/CV class ships. The riser is in good condition with all wire size measurements greater than 90 percent of original diameter. The riser enters the bottom at a water depth of 40 feet.

This mooring is in satisfactory condition for continued use as a class C mooring.

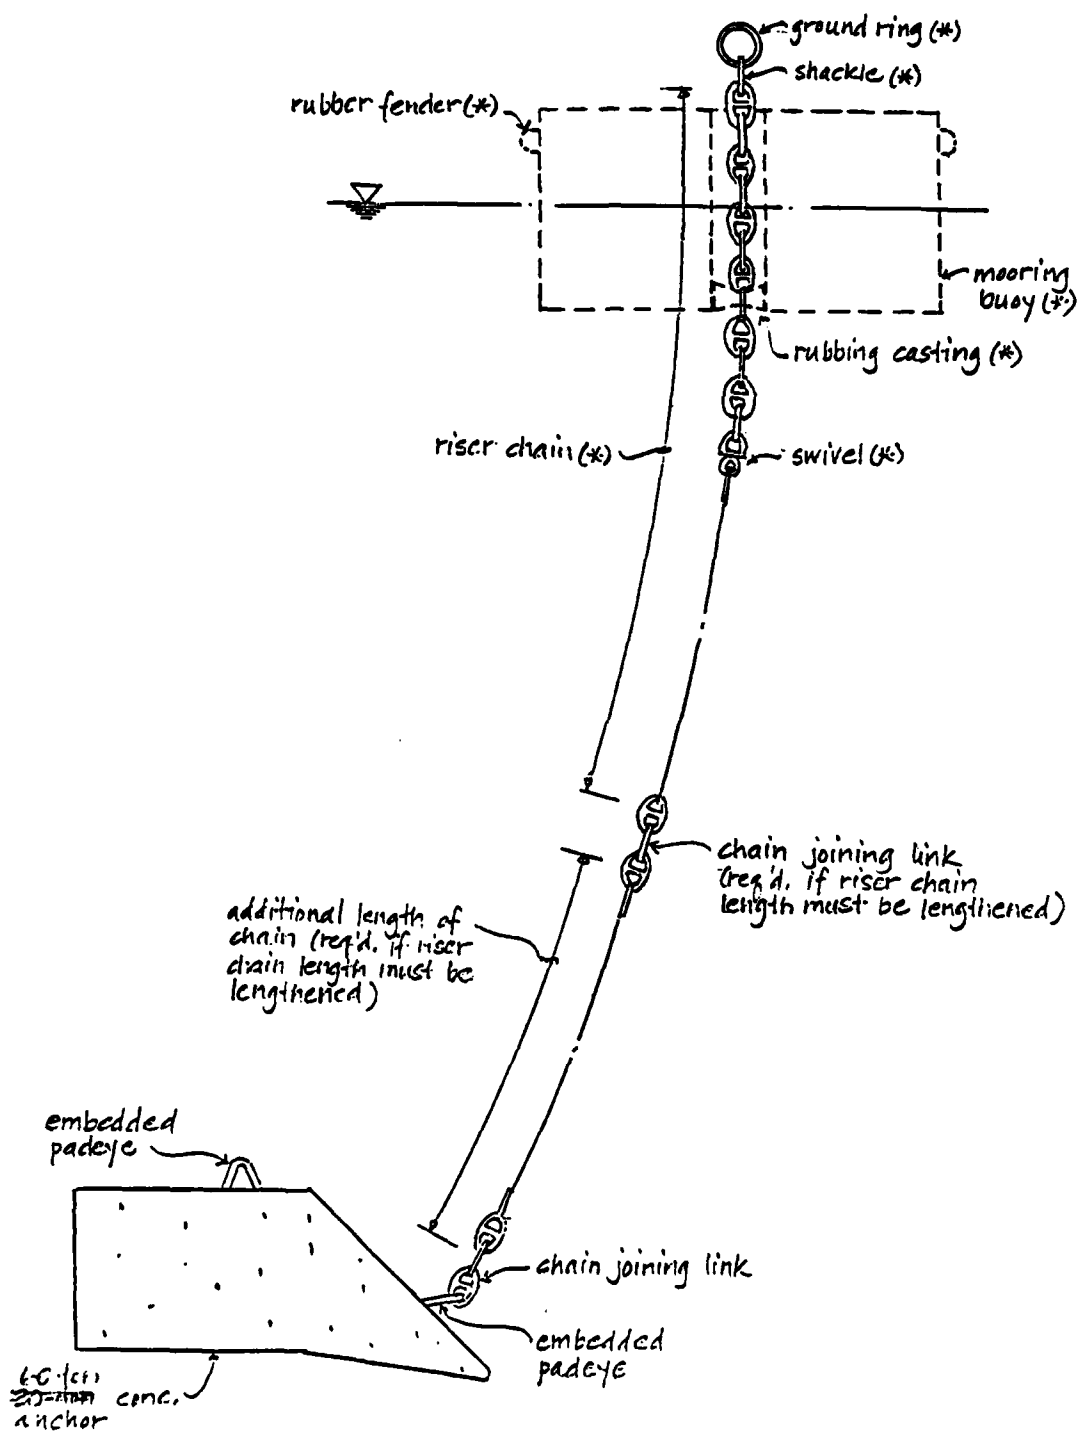
**MOORING DP2S
SCHEMATIC DRAWING**

INSPECTION REPORT

This is a 12-foot-diameter, 6-foot-high drum-type buoy with a hawsepole. The buoy is fiberglass coated and has two rubber fenders and a galvanized pipe chafing rail, all in good condition. The top metal plate and top hardware are also in good condition.

Based on visual inspection of the buoy and riser, the mooring appears to be in satisfactory condition for use as a class F mooring.

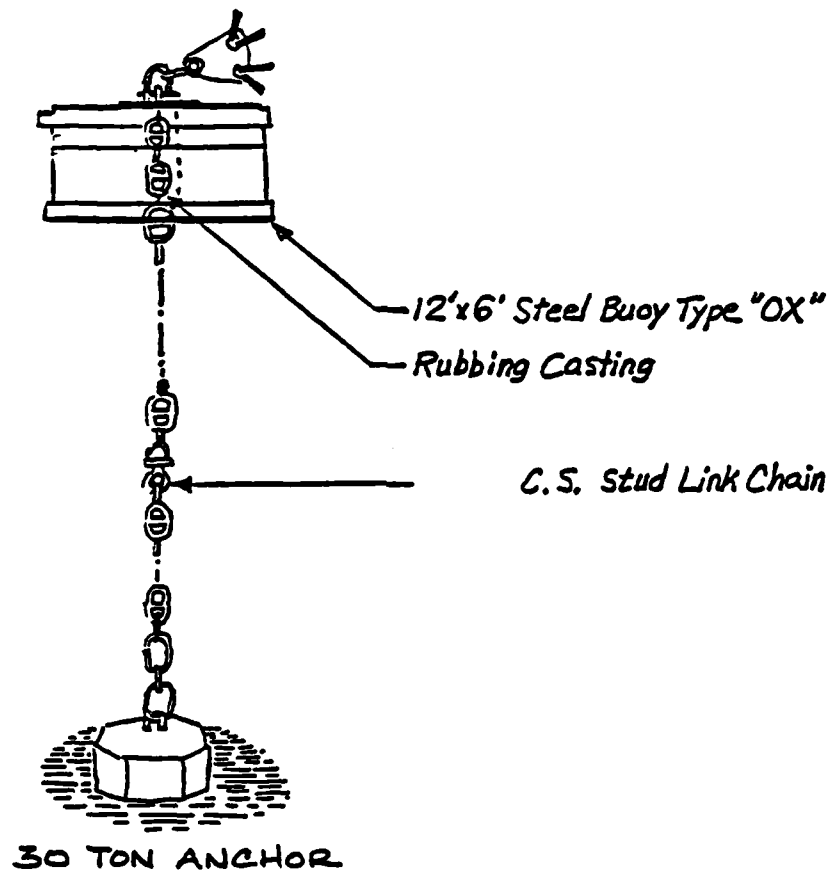
MOORING T1S
SCHEMATIC DRAWING

INSPECTION RESULTS
